ROYAL AIRCRAFT ESTABLISHMENT
(FARNBOROUGH)

TECHNICAL NOTE No: MECH. ENG. 249

**CONTINUOUS-ROD WARHEAD
LETHALITY TRIALS AGAINST
STATIC AIRCRAFT TARGETS
(RODS 3/16 inch x 3/16 inch CROSS-SECTION)**

D. A. Hancock, A.M.I.Mech.E., A.F.R.Ae.S.

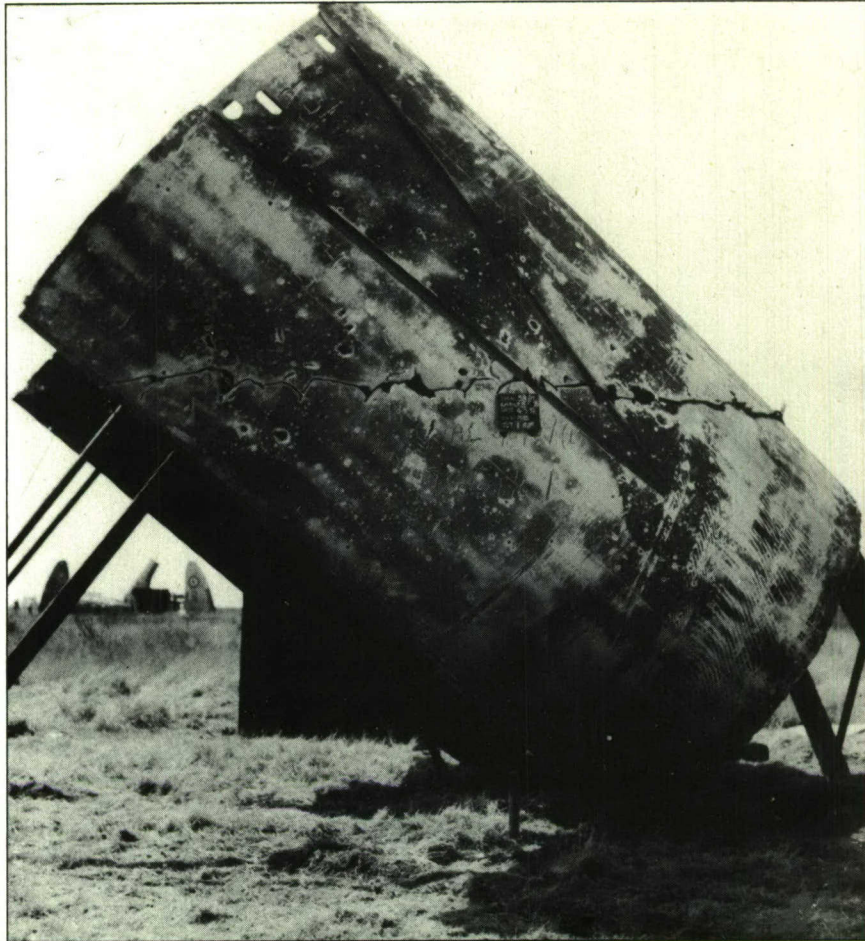
a. ROD ENTRY

b. ROD EXITS

FIG.9. VALIANT FUSELAGE AT 45° TO THE
PLANE OF RODS. (TABLE I, I a)

Target	Damage	A/C Kill Assessment
1. <u>Valiant Fuselage</u>		
(a) Target 1, Layout No. 3. Impact at normal 45° across fuselage.	15 ft cut (35% of circumference) in skinning (18 SWG and 16 SWG). 26 stringers (18 SWG) severed (35% of total). 6 frames (18 SWG) severed. $\frac{1}{8}$ in. groove in bomb bay longeron.	50% 'A'

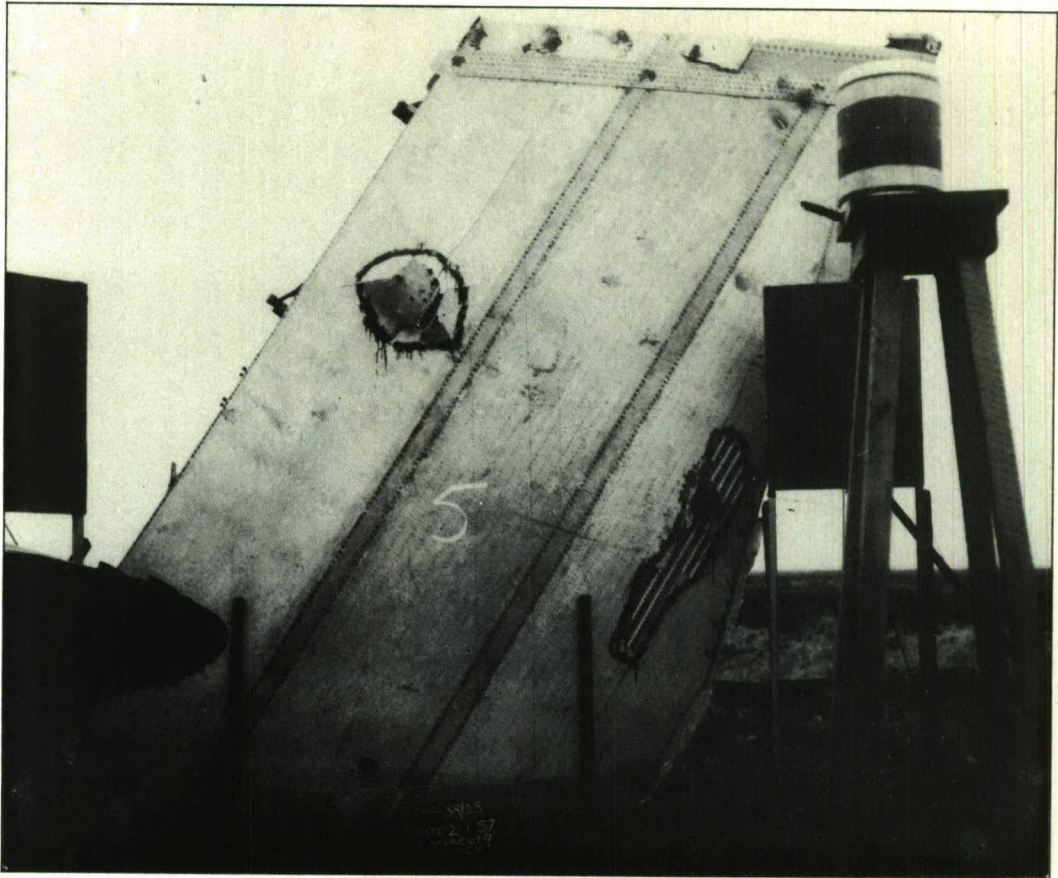
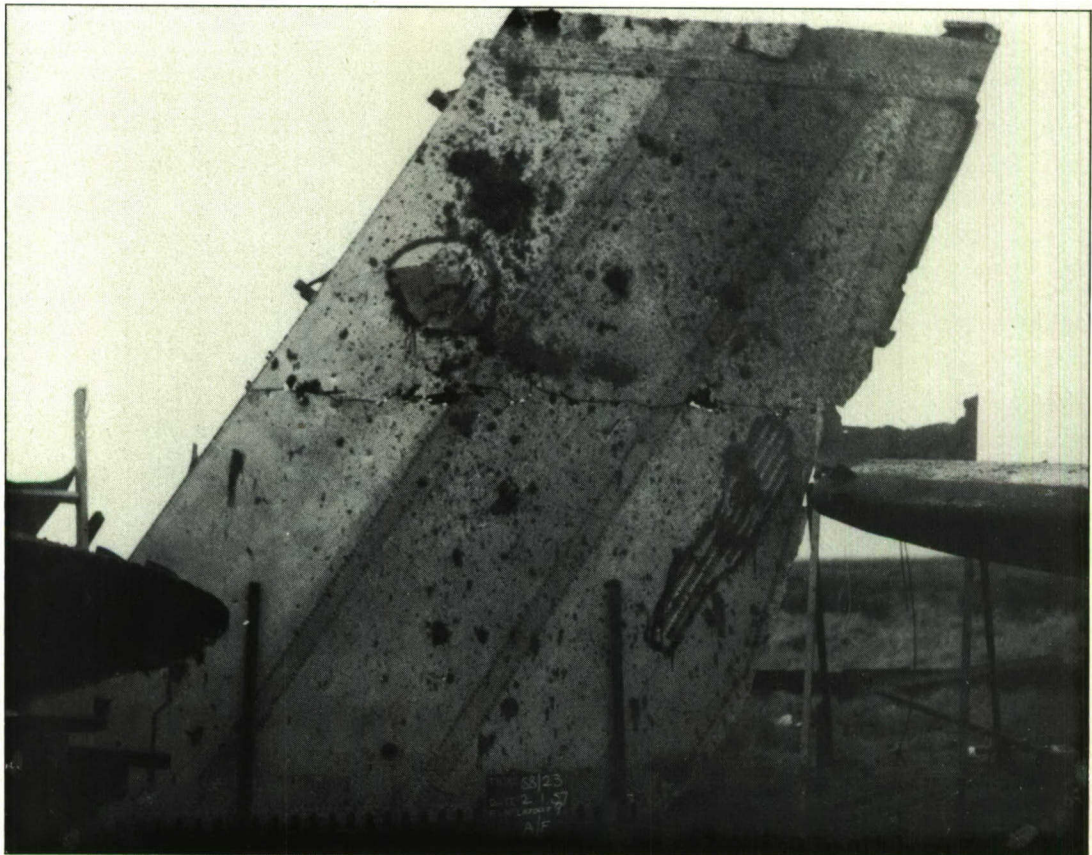
a. BEFORE DETONATION

b. AFTER DETONATION, ROD ENTRY

FIG.11. VICTOR WING AT 90° TO THE
PLANE OF RODS (TABLE I, 3 a)

3. <u>Victor Wing.</u>		
(a) Target 5, Layout No. 6. Impact at normal across wing.	9 ft 9 ins cut (100% of chord) in upper surface sandwich skinning (14, 16, 14 SWG). Rear spar upper boom severed. Mid spar upper boom severed. Line of fragment holes across lower surface sandwich skinning.	100% 'A'

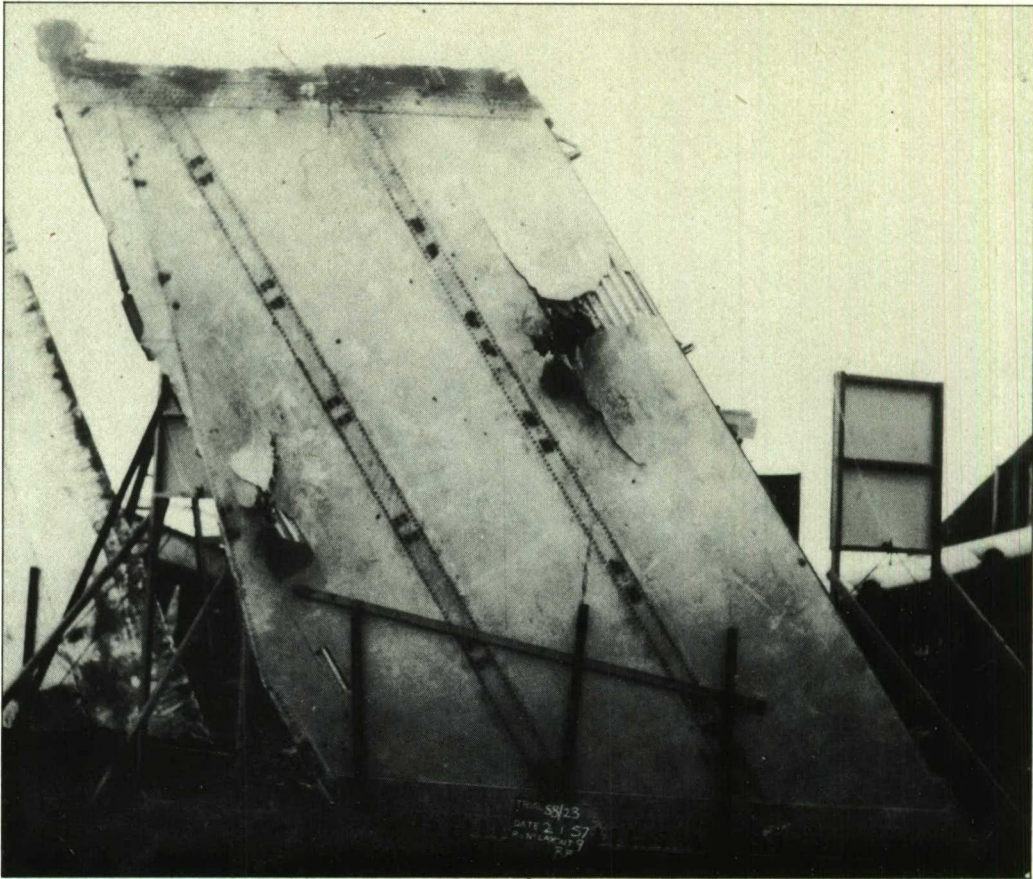
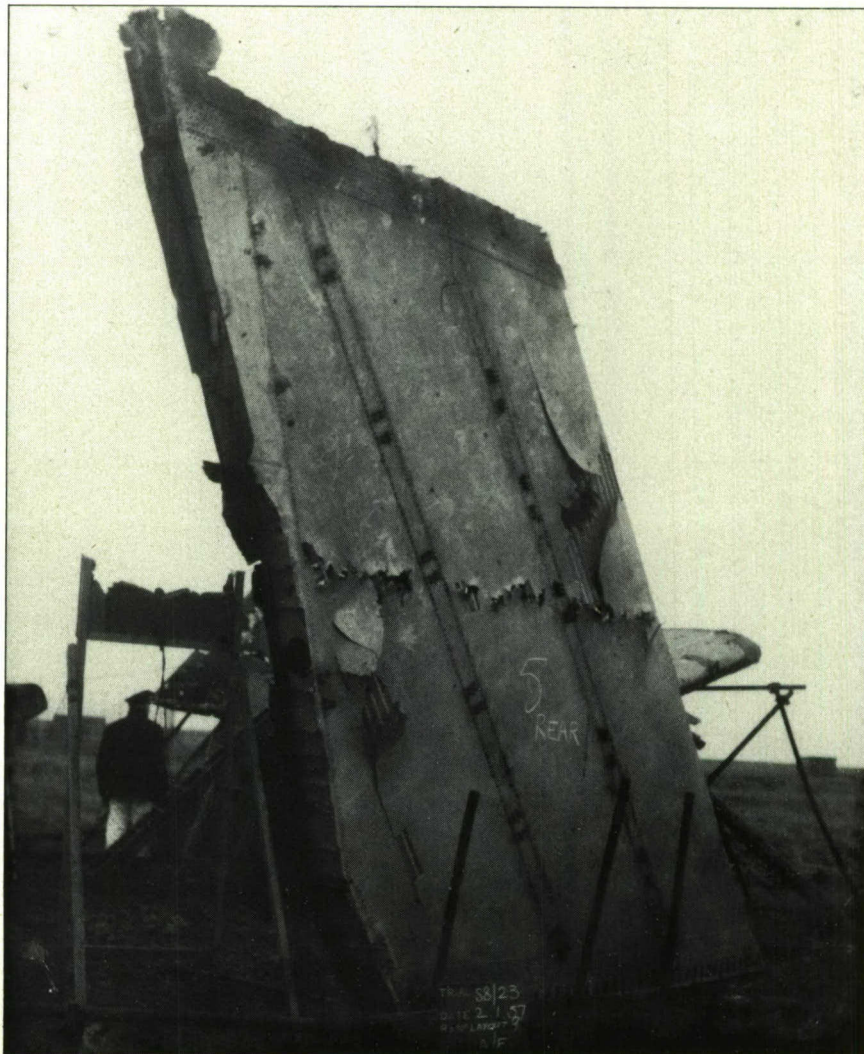
a. BEFORE DETONATION

b. AFTER DETONATION, ROD EXITS

FIG.12. VICTOR WING AT 90° TO THE
PLANE OF RODS (TABLE 1, 3 a)

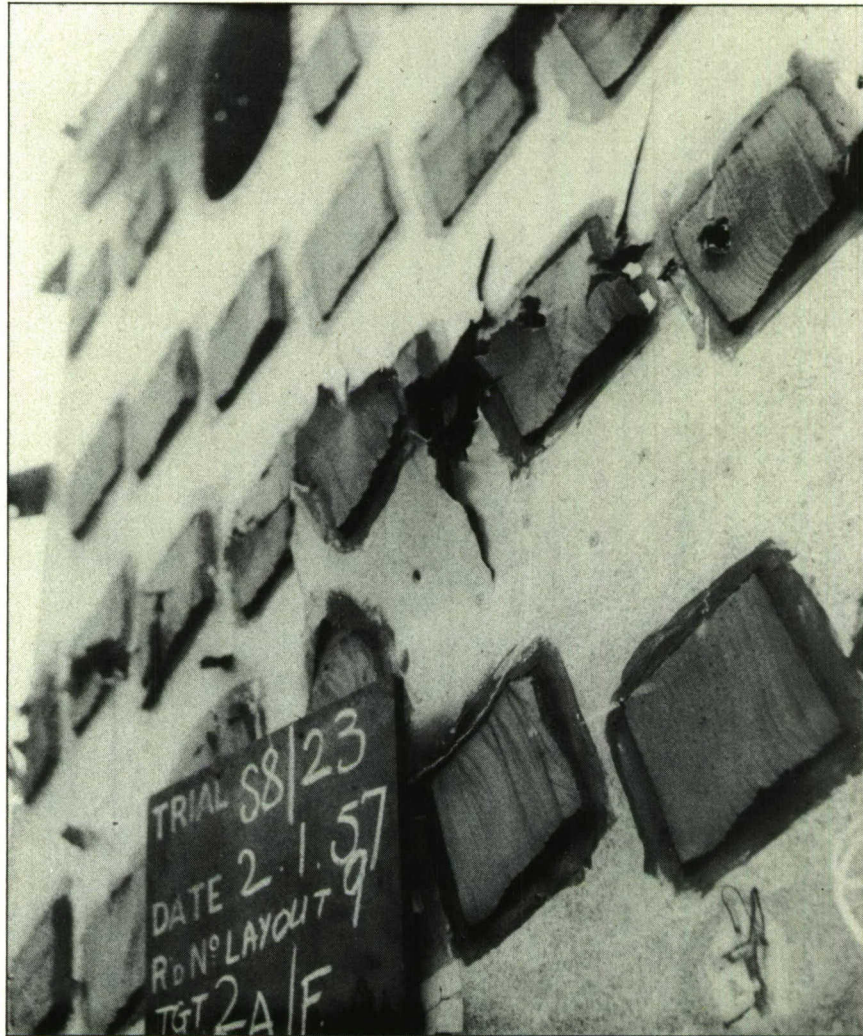
FIG.15. SHATTER CRACKS IN COMET WING.
(TABLE I, 5b)

6.3 Only one example of "shatter-cracking" in the high-strength alloy skins was noted, this being on the exit side of the attack against a Comet wing (see Fig. 15). None of the wing sections was under load at the time of the attack; it is not known whether this would have any effect on the results obtained.

5. <u>Comet Wing.</u> (a) Target 1, Layout No.6. Impact at 75° to normal across wing. (b) Target 2, Layout No.6. Impact at normal across wing.	3 cuts, 4 ft, 3 ft and 2 ft (80% of chord) in upper surface skinning (14 SWG). 6 stringers severed + 1 x 50% cut. Traces of scoring on skin. 12 ft out (100% chord) in upper surface skinning. Stringers and webs almost completely severed. Continuous row of fragment holes across lower surface skinning. 8 stringers severed, the remainder between 50% and 80% severed. Front spar web out to full depth. 8 'shatter' cracks approx. 9 ins long in lower surface skinning (Fig.15).	100% 'A' 100% 'A'

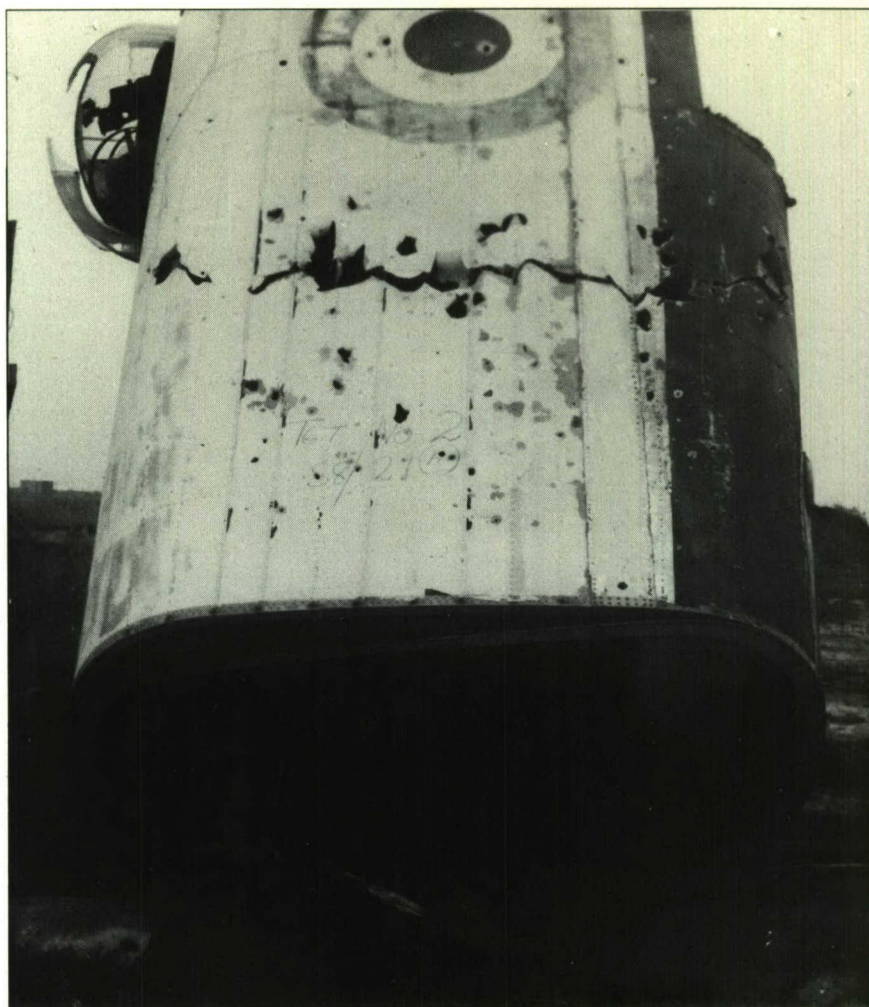
a. ROD ENTRY

b. ROD EXITS

FIG.16. LANCASTER FUSELAGE AT 45° AWAY FROM PLANE OF RODS (TABLE I, 6b)

6. <u>Lancaster Fuselage.</u> (a) Target 1, Layout No.4. Impact at normal across fuselage. (b) Target 2, Layout No.4. Impact at 45° to normal across fuselage.	2 cuts, 42 ins and 14 ins (20% of circumference) in skinning (22 SWG). 9 stringers severed + 7 x 50% cut (35% of total). Flange of starboard longeron severed. Port longeron holed. Turret frame 75% severed. Fragment holes over 6 ft fuselage length. 2 cuts, 78 ins and 16 ins (30% of circumference) in skinning. 12 stringers severed + 2 x 50% cut (35% of total). Starboard longeron severed.	Not Structurally lethal. 100% 'A'

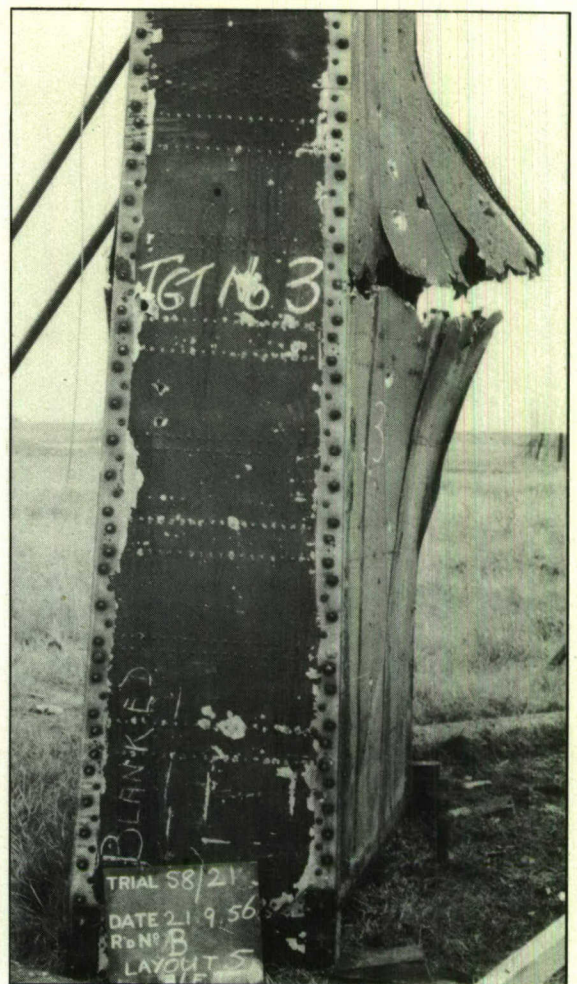
a. ROD ENTRY, FRONT VIEW

b. ROD ENTRY, SIDE VIEW

c. ROD EXITS

FIG. 18. LANCASTER WING (TANK SEVEN-EIGHTS FILLED WATER)
AT 90° TO THE PLANE OF RODS (TABLE I, 7d)

6.5 The presence of liquid in a wing structure appeared to reduce the structural damage on the exit side, the rods being retarded or brought to rest in the liquid. The entry side damage was slightly increased, usually in the form of skin bulging, due, presumably, to the pressure wave. It is likely that the configuration of the liquid container (fuel tank) and the amount of liquid present will affect the extent of the damage; further trials would be needed to elucidate these effects.

Target	Damage	A/C Kill Assessment
7. <u>Lancaster Wing (Contd)</u>		
(d) Target 3, Layout No.5. Tank $\frac{7}{8}$ filled water. Impact at normal across wing.	10 ft out (100%) in upper surface skinning in interspar region, with skinning bulged up to 12 ins over 5 ft span, with joint opened. 24 in. out in L.E. upper skinning. 15 in. out in L.E. lower skinning. T.E. not fitted. No damage to lower surface skinning in tank area. 10 stringers severed (50% of total). $\frac{1}{4}$ in. groove in F.S. upper boom. $\frac{1}{4}$ in. groove in R.S. upper boom. F.S. lower boom 20% damaged.	Not Structurally lethal.
